*Fracture Characterization of the
Bandelier Tuff in OU-1098 (TA-2 and TA-41)*

Kenneth H. Wohletz

ABSTRACT

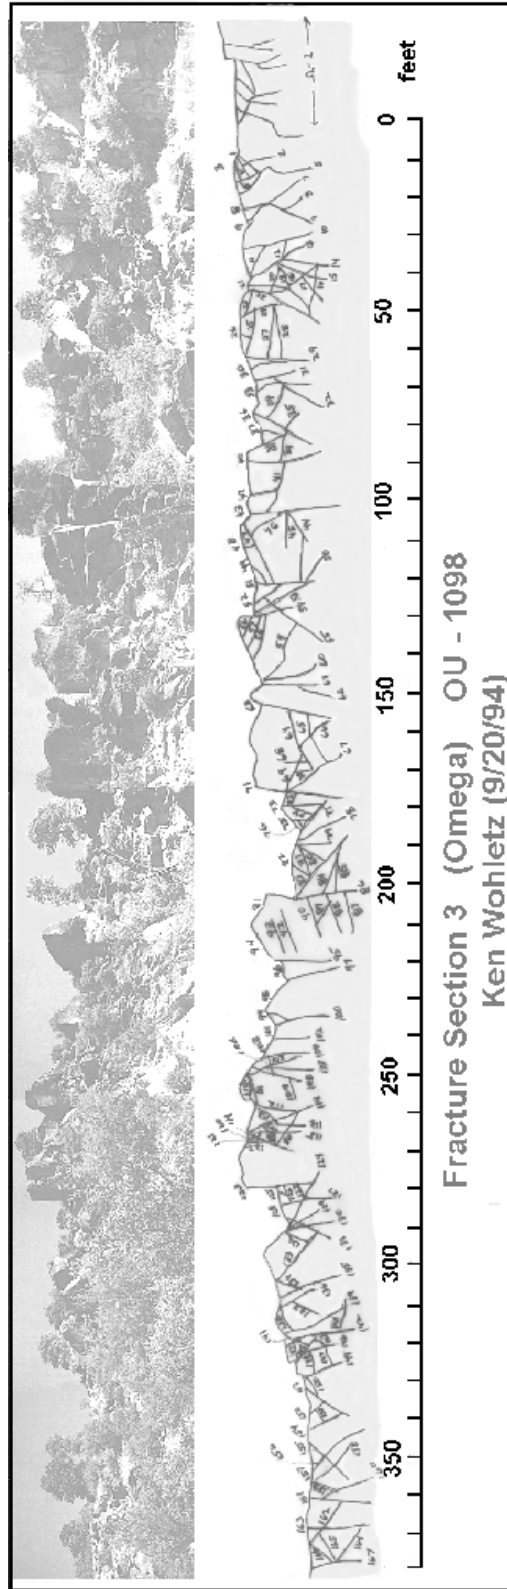
Figure 3. An example fracture photomosaic map (map 3) adjacent to Omega Site (TA-2-1). Each documented fracture has a number for its identification in the fracture data base.

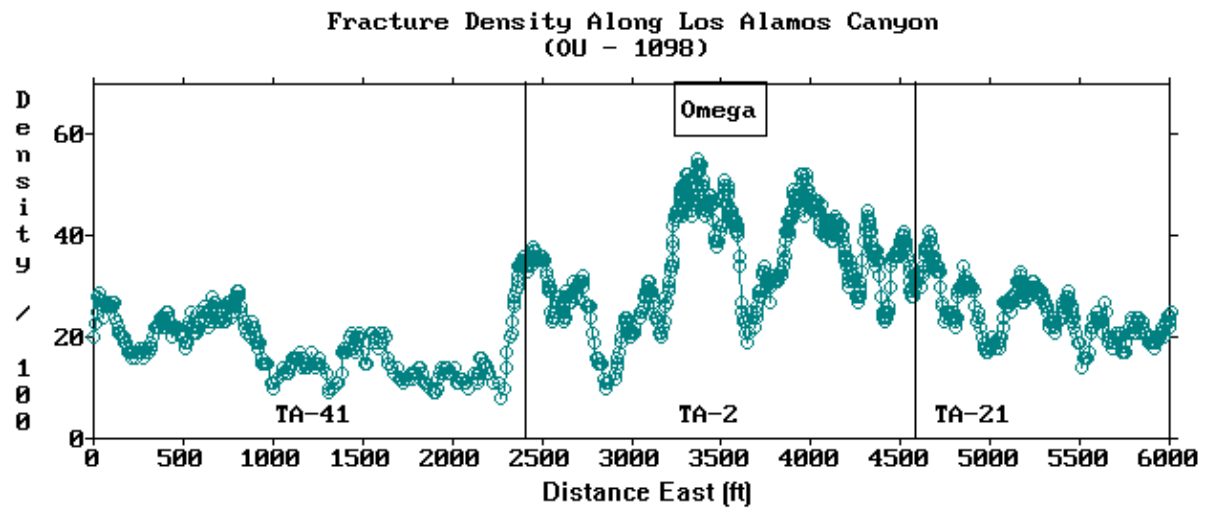
Fracture Density. Linear fracture density is portrayed in Figure 4 as the number of fractures within a 100-foot interval centered on each fracture for the section starting west of building TA-41-4 and extending 6013 feet down Los Alamos Canyon. From Table 1, fracture density increases from a western background value of 22 fractures per 100-foot interval to over 40 within the GMFZ and then declining to about 30 east of GMFZ. The densities of NW and NE fractures are virtually the same. From previous studies, background fracture densities in the Bandelier Tuff are about 20 fractures per 100-foot interval (Vaniman and Wohletz, 1990; Wohletz, 1995). The value of 30 fractures per 100-foot interval east of the GMFZ likely shows the influence of another fault zone existing near Material Disposal Area V (MDA-V) in TA-21 (~7000 feet east; Wohletz, 1995). Figure 4 shows the prominent rise in fracture density within TA-2 near Omega Site, reaching maximum values between 50 and 60 fractures per 100-foot interval. At 2500 feet another peak in fracture density is apparent. Figure 5 is an enlargement of Figure 4 over the area adjacent to Omega Site building TA-2-1, which likely constitutes a western branch of the Guaje Mountain Fault; the eastern branch exists about 400 feet east of TA-2-1.

Figure 4. Fracture density shows the number of fractures per 100-foot interval centered on each fracture along the traverse of approximately 6000 feet. Note the increase in density from about 3200 to 4200 feet (adjacent to Omega Site), which is the signature of the Guaje Mountain Fault Zone.

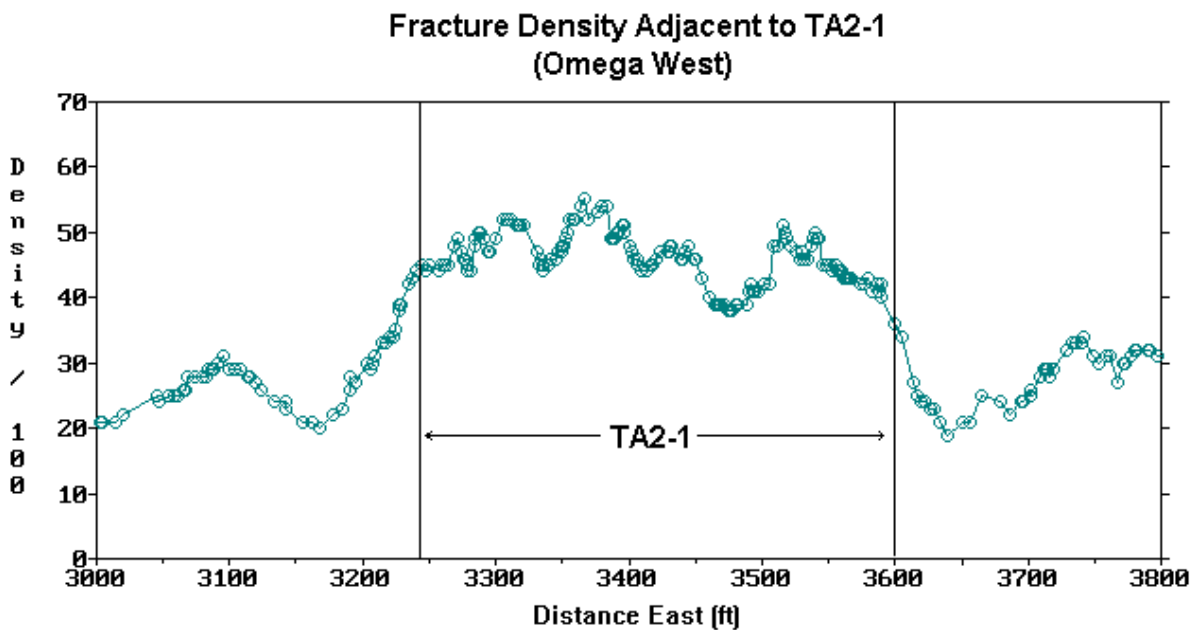
Figure 5. Detail of fracture density from 3000 to 3800 feet along the fracture traverse in the region of building TA-2-1 (Omega West reactor).

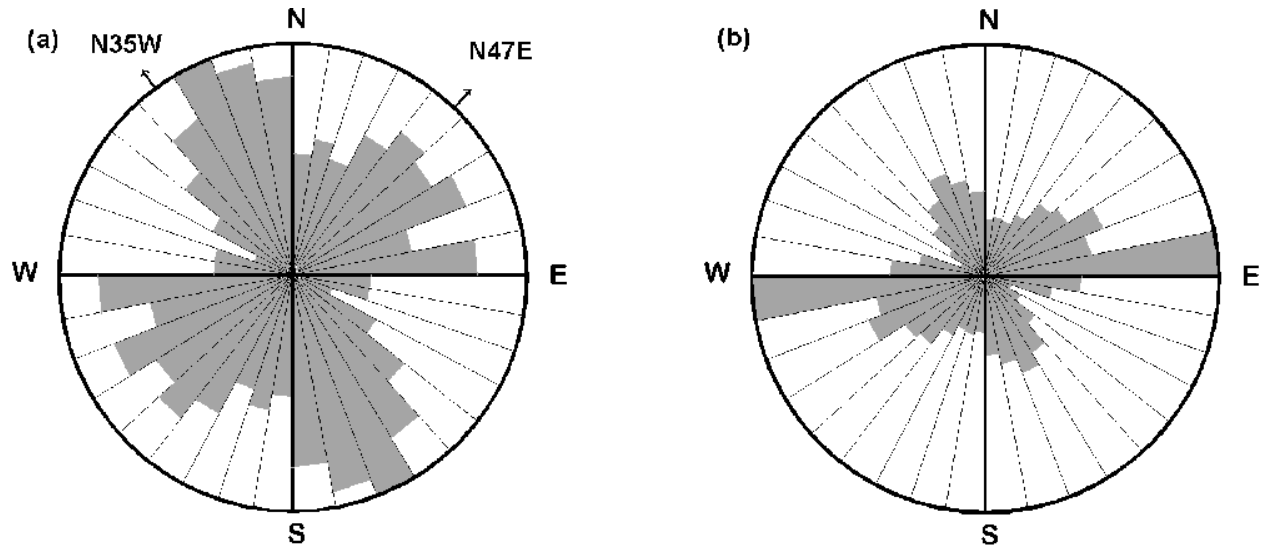
Fracture Strike. Plotted in a rose diagram (Fig. 6a), fracture strikes show two groupings with mean strikes at N35W and N47E, supporting the conjugate joint-set assumption for distribution of the fractures. As mentioned above, measurement of fractures along a nearly E-W line precludes unbiased representation of fractures nearly parallel to that trend. A compensation algorithm can be defined based on the assumption that the observed fracture abundance is inversely proportional to the cosine of the angle between the fractures and the perpendicular to the line of observation. This algorithm is modified to take into account that the fracture traverse is not a straight line and represents about 20 degrees of variability (canyon wall reentrants allow measurement of some of the fractures striking parallel to the canyon); hence, the maximum compensation will not be infinity but about a factor of 3 [$1/(\cos 70^\circ)$]. Figure 6b is a rose diagram depicting this compensation, which defines a hypothetical but dominant E-W grouping (note that rose diagram depicts E-W trend in bin adjacent to E-W line). The angle between mean strikes is 82° (NW and NE sets) and between 43° (EW and NE sets) and 55° (EW and NW sets).

Figure 6. (a) Rose diagram showing the frequency of measured fracture strikes with conjugate set mean values at N35W and N47E. (b) Compensated rose diagram showing hypothetical frequencies of fractures nearly paralleling the fracture traverse.

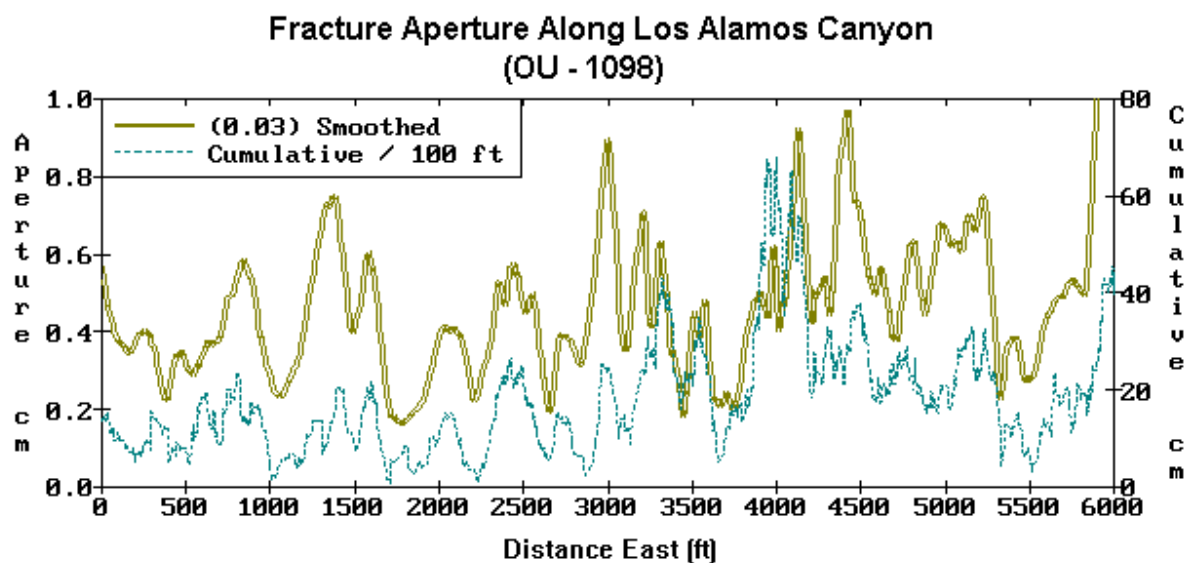
Figure 9. LOWESS (0.03; 45 point) smoothed curve of fracture apertures and the curve for cumulative fracture aperture per 100-foot interval centered on each fracture. The cumulative curve shows peak values in the region of the GMFZ.

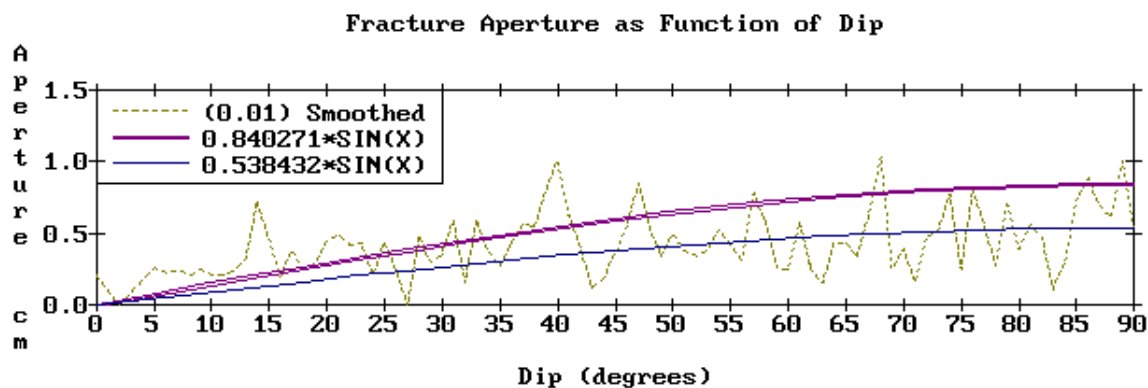
Figure 10. LOWESS (0.01) smoothed curve (dotted) of fracture apertures as a function of dip. Sine curves are shown for a best fit of all aperture data (double) and best fit of smooth data (single). This plot shows that there is a general observed increase in fracture aperture with increasing fracture dip, such that horizontal fractures generally show little or no aperture while vertical ones generally show apertures of about 0.8 cm.

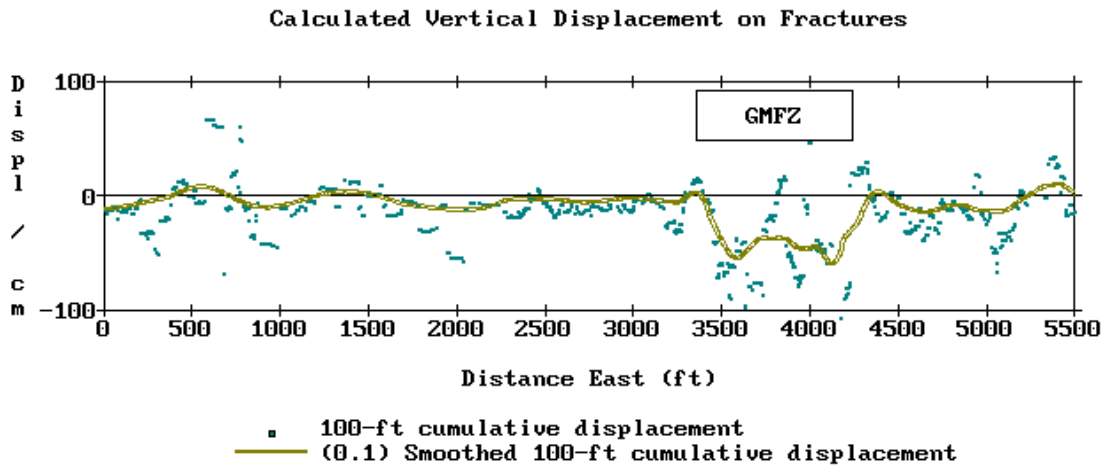
Figure 12. Fracture aperture per 100-foot interval (interval centered on each fracture) and LOWESS (0.1) smoothed curve of these data calculated as shown in Figure 11. Note the negative (down to the west) signature over the GMFZ between 3200 and 4200 feet.

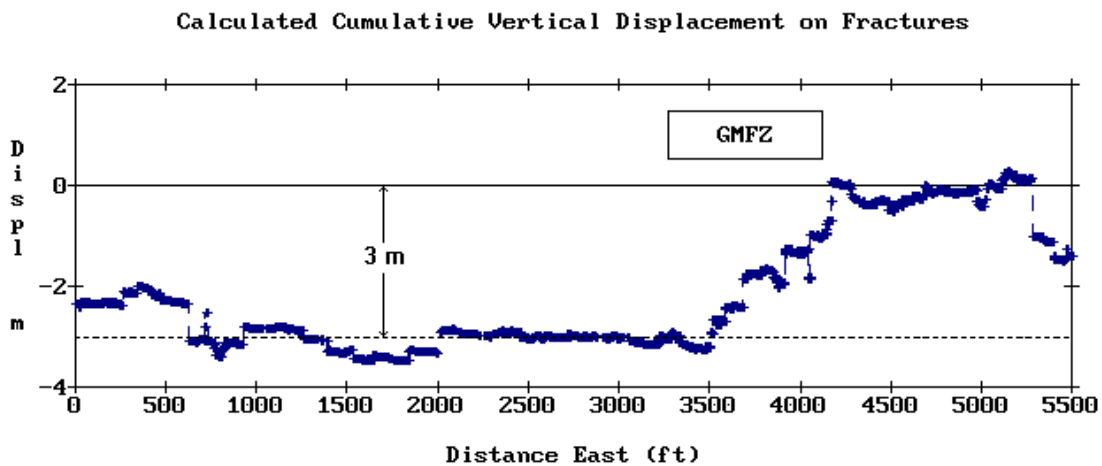
If in fact tectonic displacement has been accommodated by the 409 documented fractures over the GMFZ (3200 to 4200 feet) by incremental, vertical displacement on each fracture, then with summation of these displacements one can test the model of Gardner and House (1987) that shows downdrop on the west side of this fault zone. Because most fractures do not show measurable evidence of incremental displacement, an alternative method is proposed here, a method based on the assumption that fracture apertures have developed by vertical displacement along initially closed cooling joints. Figure 11 illustrates this method, showing how a vertical displacement along a fracture produces a fracture aperture where the apparent downdrop equals the aperture divided by the cosine of the dip. This method also requires the assumption that vertical fractures produce no aperture, which is incorrect considering observed data (Fig. 10); however, if vertical fractures were included in this method, then an infinite vertical displacement would arise, which is obviously incorrect. Furthermore, cooling contraction of the tuff may have produced fracture apertures, but I note that many localities in the Bandelier Tuff show cooling joints having no aperture. Keeping in mind the above assumptions, an application of this method (Figs. 12 and 13) does show an apparent cumulative downdrop of approximately 3 m (10 ft) to west has been accommodated by fractures in this zone. In support of this calculation, Vaniman and Wohletz (1990) calculated ~2 m of vertical displacement on the GMFZ where it crosses East Jemez Road to the south of Los Alamos Canyon. In addition this former study noted an inflection of the Los Alamos Canyon stream gradient of about 20 feet over the GMFZ, which is a common geomorphic feature of fault displacement.

Figure 13. Cumulative fracture vertical displacement calculated as shown in Figure 11. Note the apparent westward dropout over the GMFZ. Approximately 4m of apparent displacement occurs between 3500 and 4200 feet, where cumulative offset is taken from an arbitrary zero level east of the GMFZ.
